Polk County Fire Rescue

Post Incident Analysis

Residential Structure Fire

13802 Rock Ridge Road, Lakeland, FL

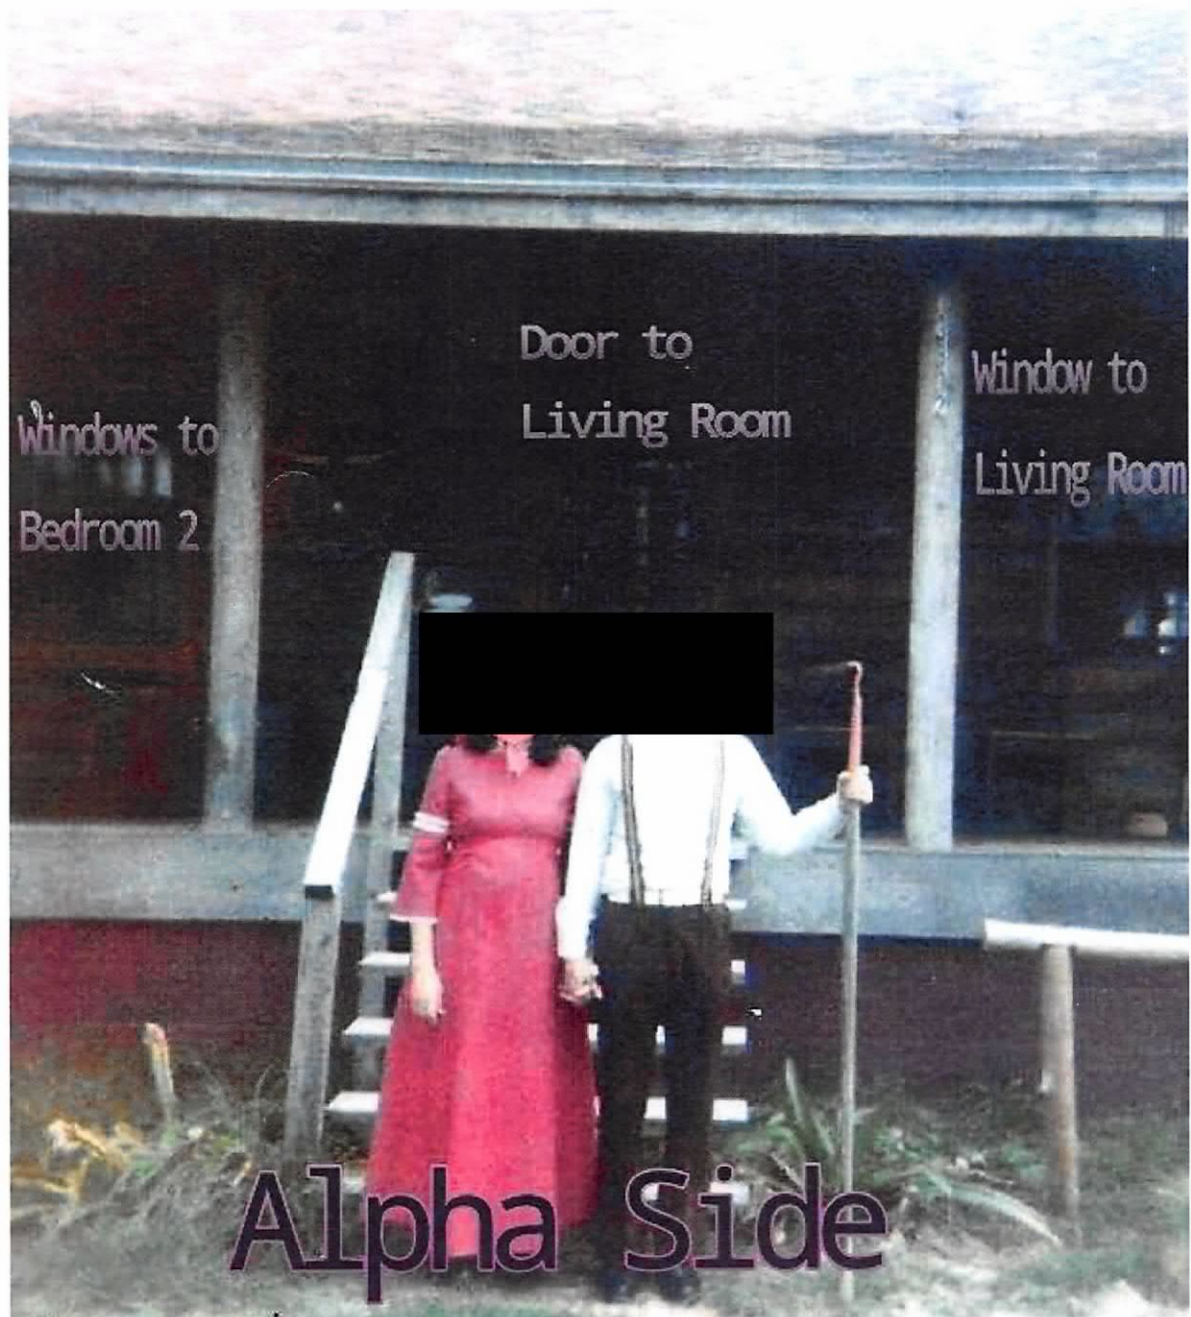
Alpha Side

Windows to
Bedroom 2

Door to
Living Room

Window to
Living Room

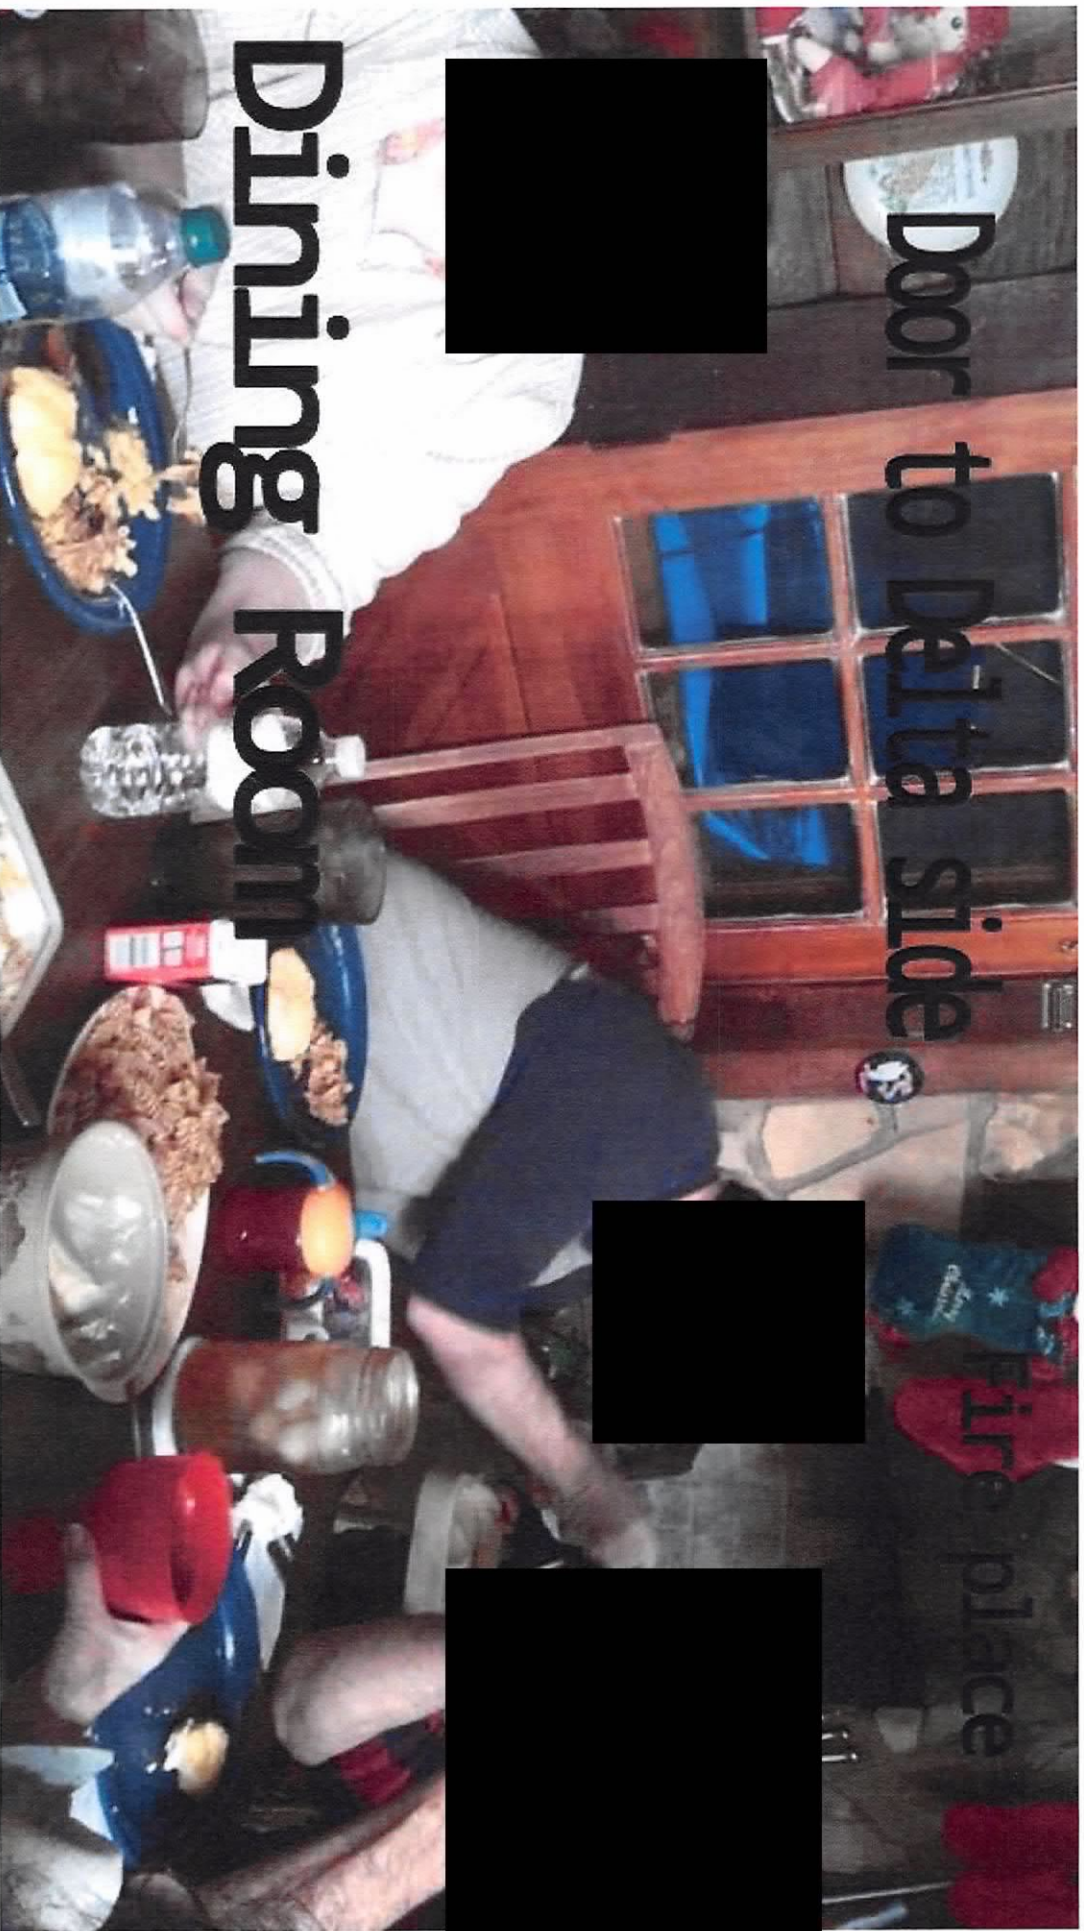
Door to Delta side

Fire place

Dining Room

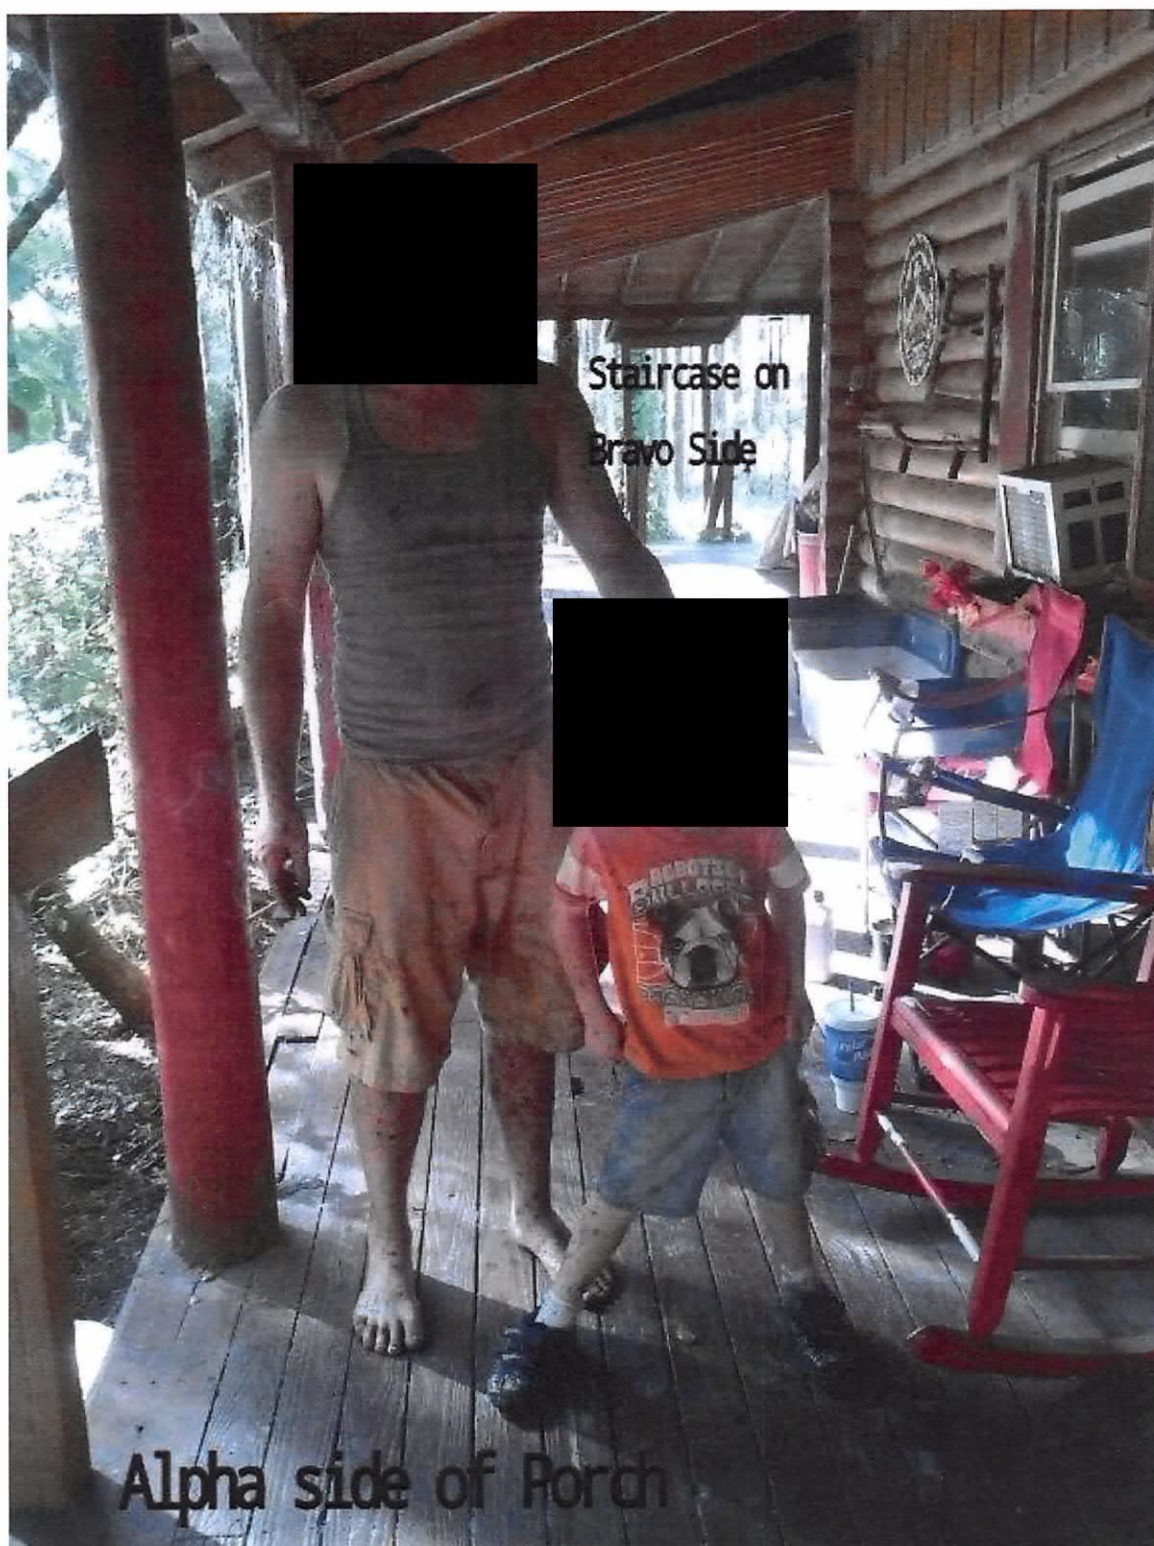
Staircase on
Bravo Side

Alpha side of Porch
